# Special Report 81-10

May 1981

## FABRIC INSTALLATION TO MINIMIZE REFLECTION CRACKING ON TAXIWAYS AT THULE AIRBASE, GREENLAND

Robert A. Eaton and Randy Godfrey

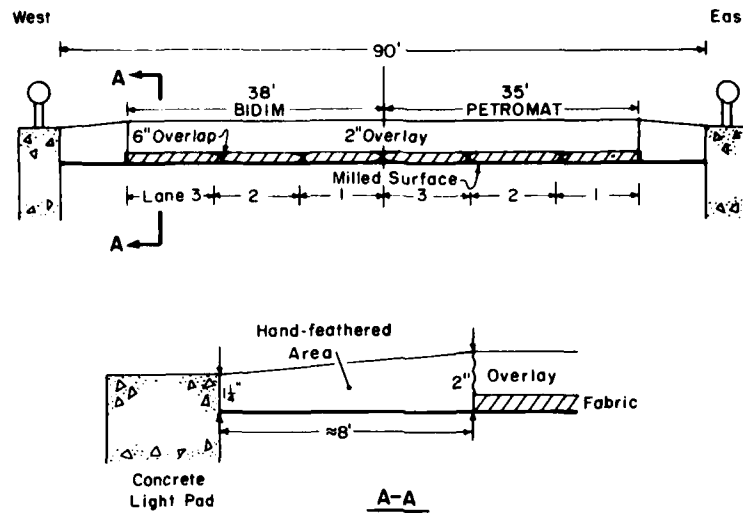
Figure 14. Cross section of taxiway 3 (not to scale).

The fabric wrinkled 30 ft from the start of lane 1 (station 2+80) (see Fig. 14 for location of lane 1) because of a misalignment with the tack coat. The fabric was cut with a pocketknife and then overlapped by 6 in. (Fig. 15). It wrinkled again at station 4+80 and was again cut and overlapped by the same amount. After the first roll ran out, the left-hand brake device was disassembled and the pipe was taken out and

The thickness of the overlay was a nominal 2 in. wherever the fabric was placed. For the 8 ft of uncovered pavement from the edge of the fabric to the concrete light pad, the asphalt was hand placed and feathered to an overlay thickness of 1-1/4 in., equal to the depth of the milling operation (Fig. 14 and 22). It took 2 hr to place the first lane which covered a 20-ft-wide strip (12 ft for 2-in. overlay; 8 ft hand-feathered down to 1-1/4 in.).
